RAPID SITE PREPARATION FOR TURBOJET VTOL AIRCRAFT

TECHNICAL DOCUMENTARY REPORT No. APL/TDR-64-125

AIR FORCE AERO PROPULSION LABORATORY RESEARCH AND TECHNOLOGY DIVISION AIR FORCE SYSTEMS COMMAND WRIGHT-PATTERSON AIR FORCE BASE, OHIO

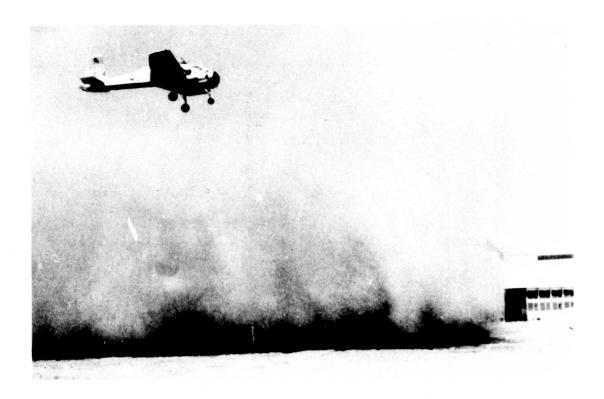
Figure 39 Surface Erosion and Dust Cloud Generated by X-14A Hovering Over Unprepared Area Adjacent to Demonstration Site

The hovering flight during which damage to the dust cover occurred illustrated that below a certain altitude (in this instance approximately 50 ft.), the aircraft must be accurately positioned over the pad to prevent erosion under the edge of the dust cover which may lead to failure of the cover. This same problem would also exist when an aircraft makes an approach to the landing site at low altitude or when descending on other than a near vertical flight path.
